MAIB SAFETY BULLETIN 1/2013

Ejection of family of six from an 8.0m RHIB in the Camel Estuary leading to two fatalities and serious injuries to two people

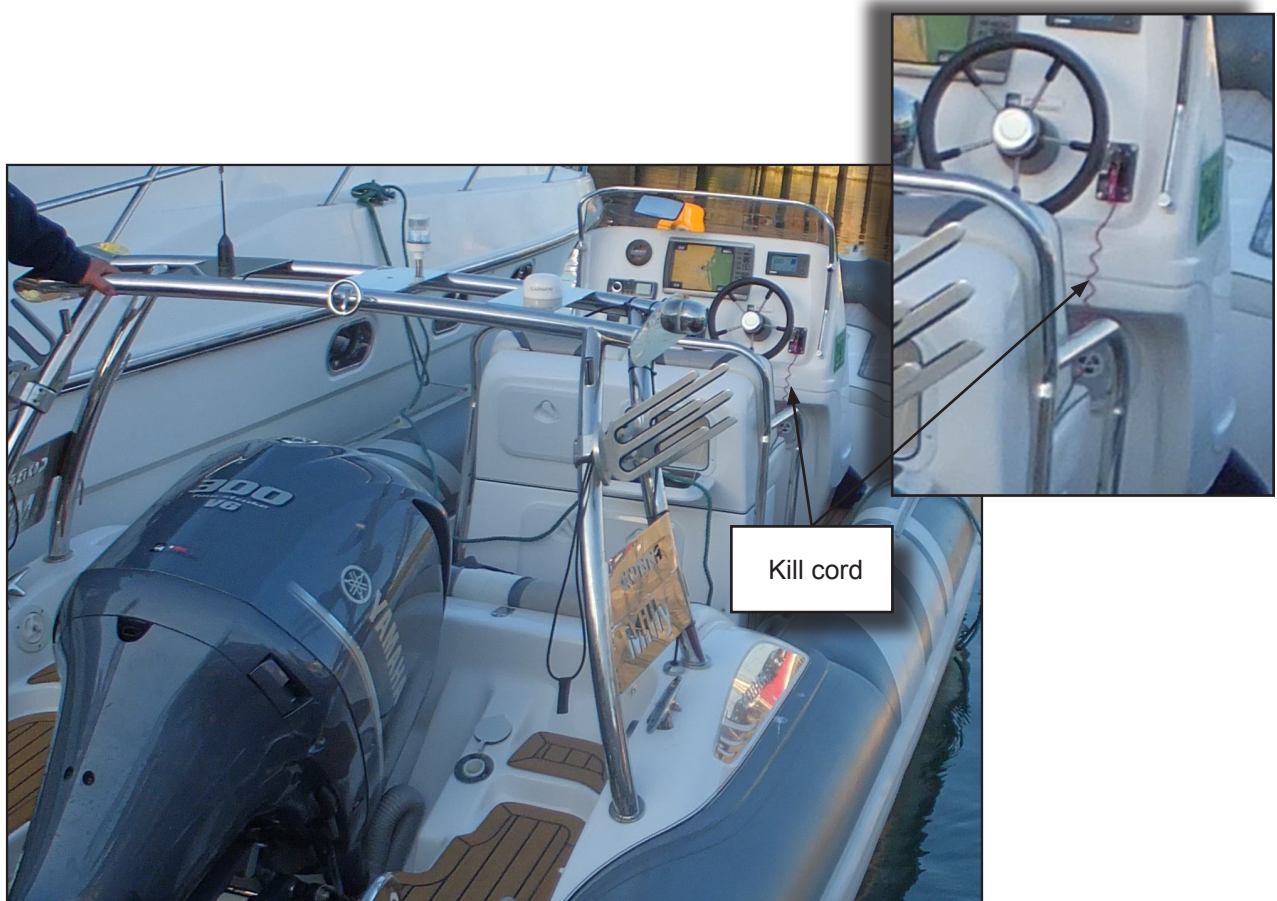
The RHIB was fitted with a kill cord (**Figure 1**), but this was not attached to the driver at the time of the accident. Consequently, when the driver was ejected from the boat, the kill cord did not operate to stop the engine and the RHIB continued to circle out of control, and at speed. As the RHIB circled, it ran over the family in the water a number of times, leading to the deaths and injuries. A few minutes later a local boatman was able to board the RHIB and bring it under control before further people were hurt.

Figure 1: Boat with kill cord in place

- Test them regularly to ensure that the engine stops when the kill cord mechanism is operated.
- Make sure that the cord is in good condition.
- Always attach the cord securely to the driver, ideally before the engine is started, but certainly before the boat is put in gear.
- Stop the engine before transferring the kill cord to another driver.
